Minolta Maxxum STsi Back Clock Button Replacement

This guide consists of removing the back clock button.

This guide will show you how to replace the back clock button for your Minolta Maxxum STsi.

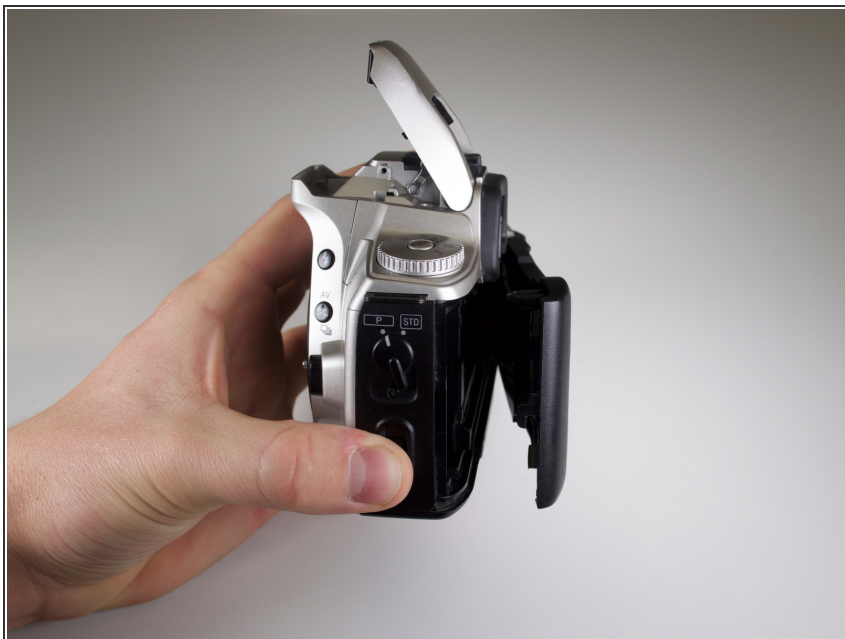
Step 1 — Back Clock Button

- Open the back panel by firmly pressing up on the back-cover release on the lower right side of the camera.

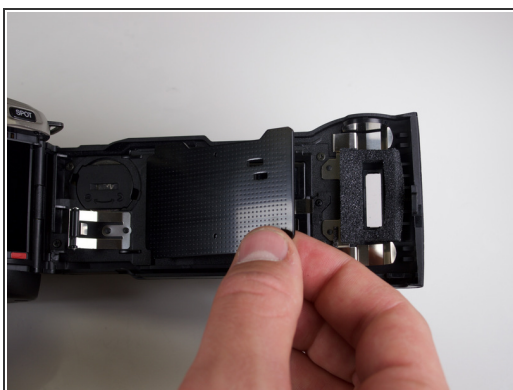
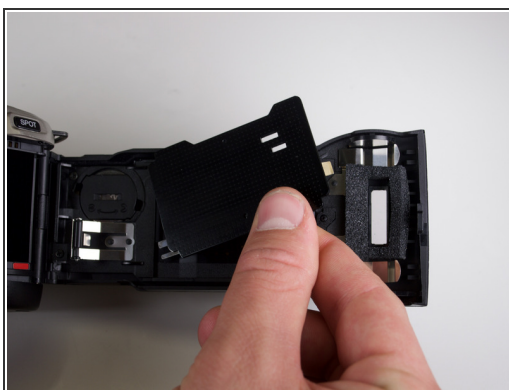
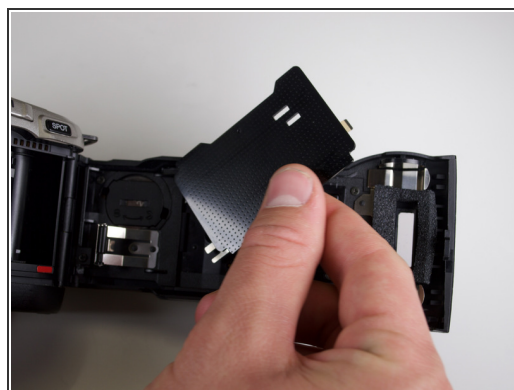
Step 2

- Remove the black case by gently lifting it with your fingers and rotating counterclockwise.

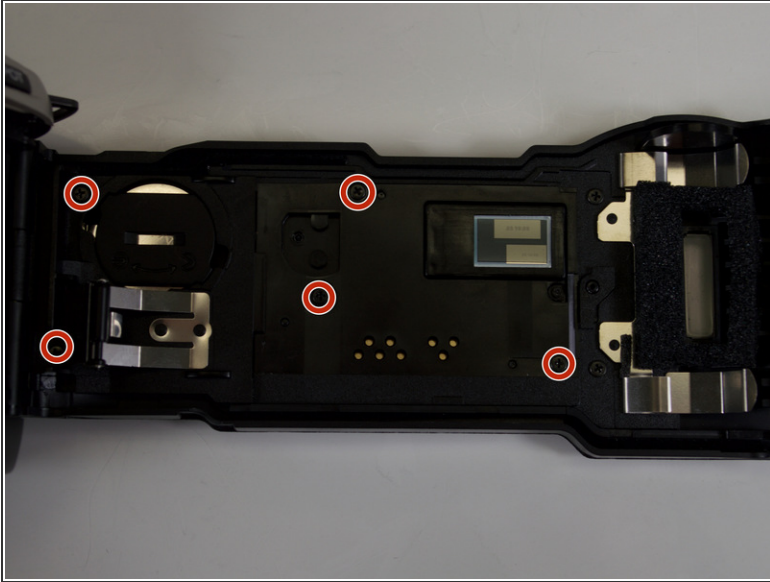
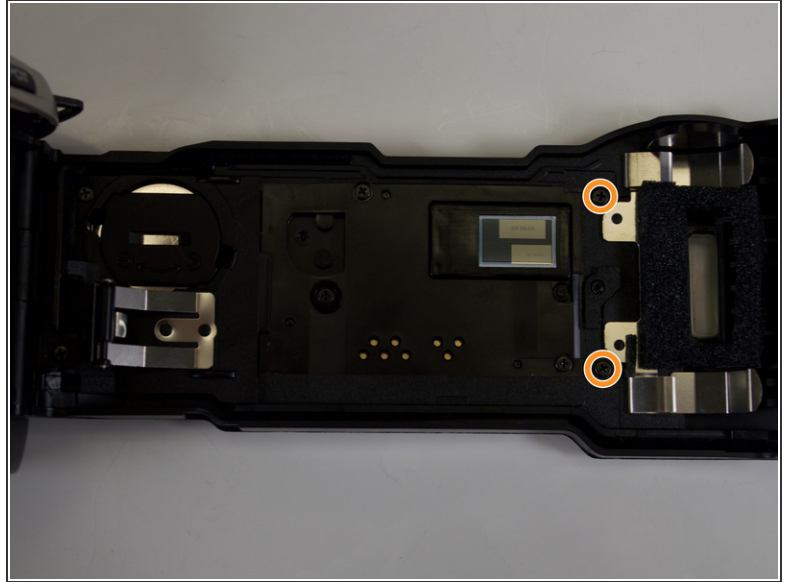
Step 3

- Remove the five black Phillips #00 2.5 mm screws from the back panel.
- Also remove the two black Phillips #00 5.0 mm screws from the back panel.

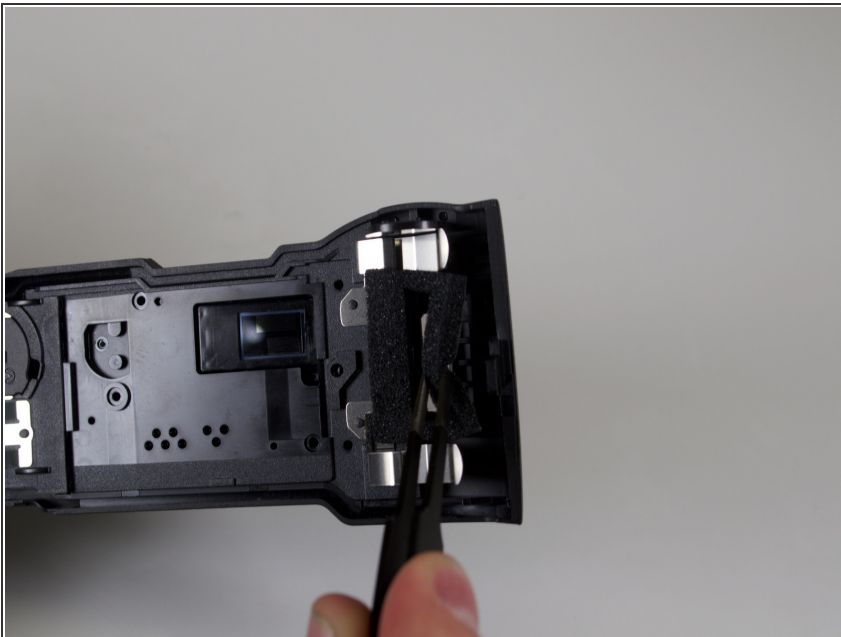
Step 4

- Use the tweezers to carefully peel back the adhesive foam connecting the back panel to the case and remove the panel.

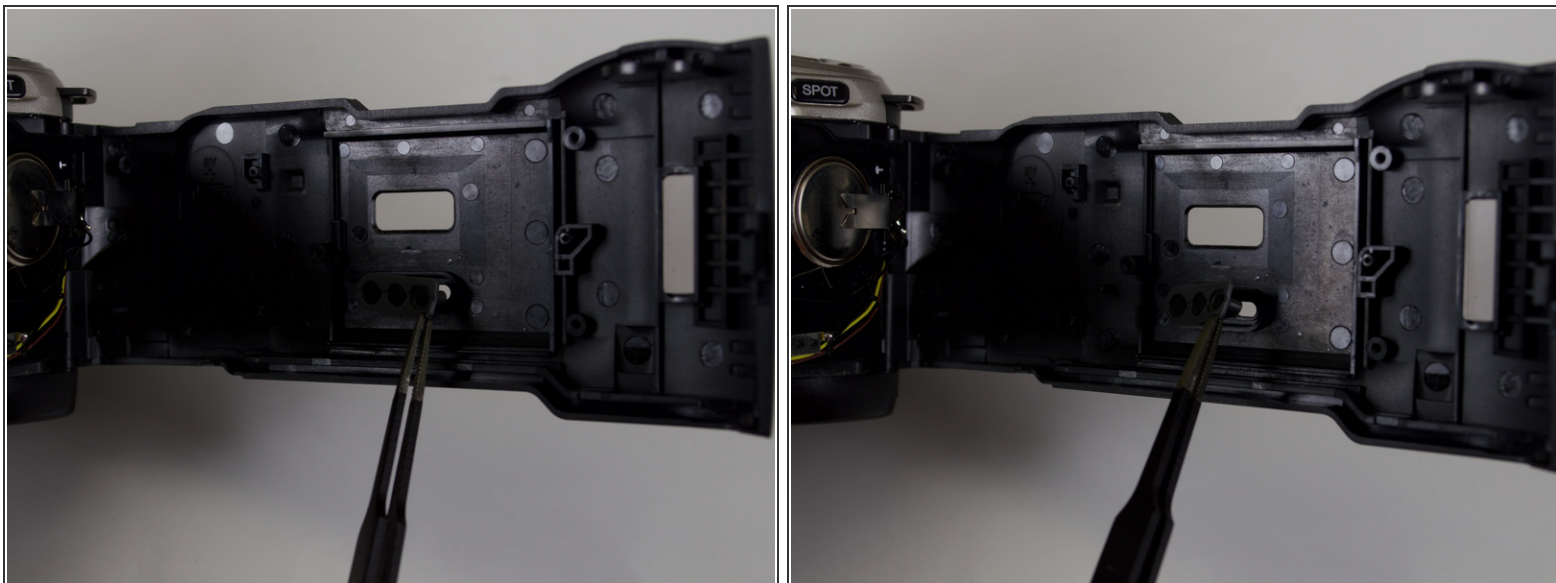
Step 5

- Use the tweezers to carefully peel off the rubber clock button.

To reassemble your device, follow these instructions in reverse order.
